Manhole Inspection Summary

Manhole # S05YY1017MH

Location Address: **5901 HIGHGATE DR**

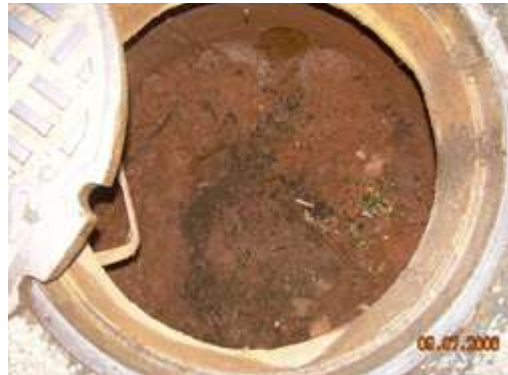
Top View

Frame leaks. Adjustment and Corbel infiltration. Corroded steps. Channel debris.

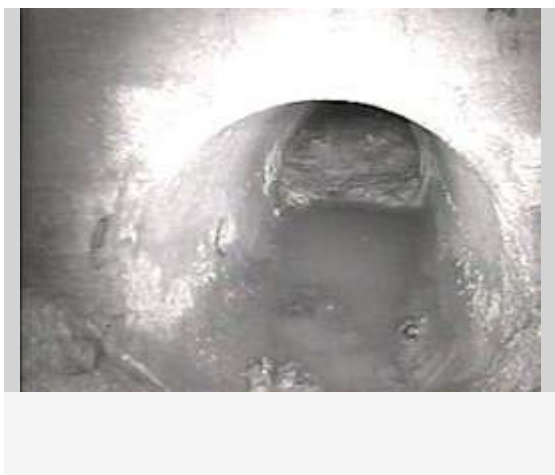
8 in. Circular Gravity Sewer
Pipe Out @ 12 O'Clock

Deposits: ☐ None ☒ **Mud** ☒ **Gravy** ☒ **Debris** ☐ Grease

Silt Depth: **1** (in.) Deposits Extent: **Light**
